ERDC/CHL TR-00-26

Navigation Study, Colorado Locks, Colorado River, Matagorda, Texas

Final report

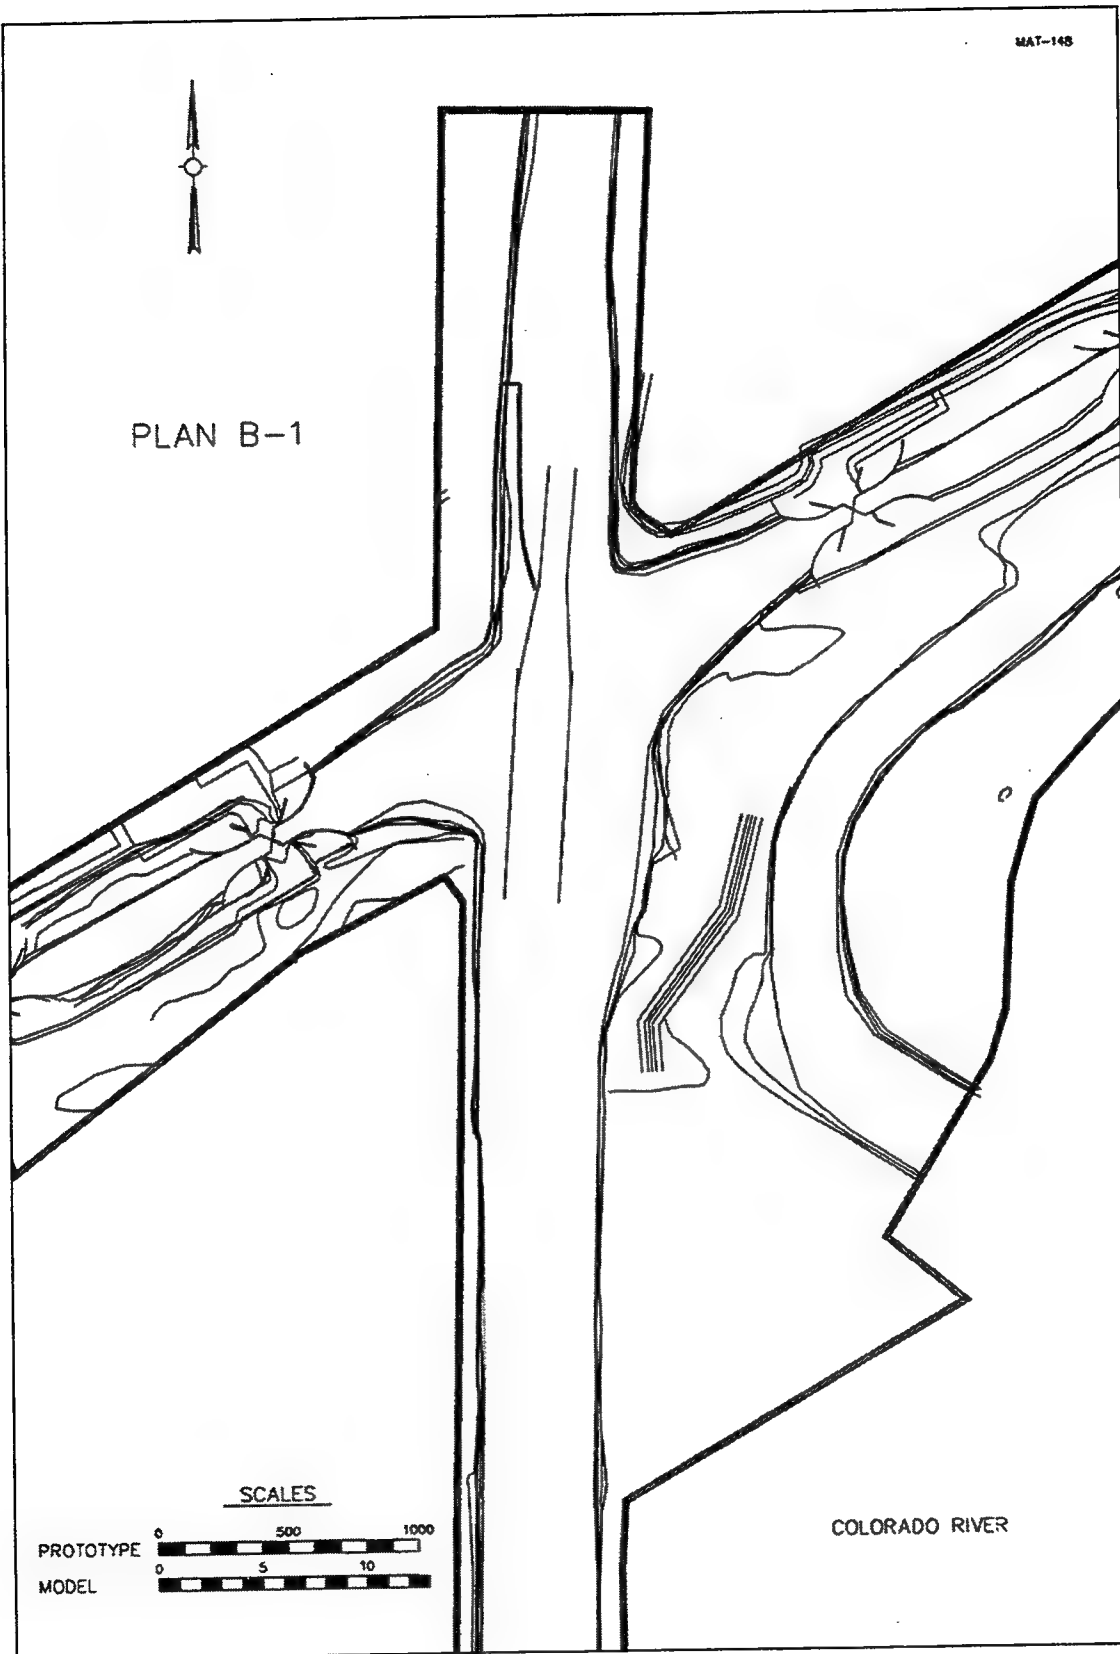
Figure 15. Plan B-1 layout

commonly controlled by the use of contraction works, similar to the L-head dike as evaluated in Plan B. Although this model could not address the effectiveness of this dike in maintenance of the deepened channel in the intersection, it could be used to evaluate how the combination of a training structure and dredging might affect navigation. Plan B-1 (Figure 15) consisted of the dredged channel as used for Plan B and the L-head dike as used for Plan A.

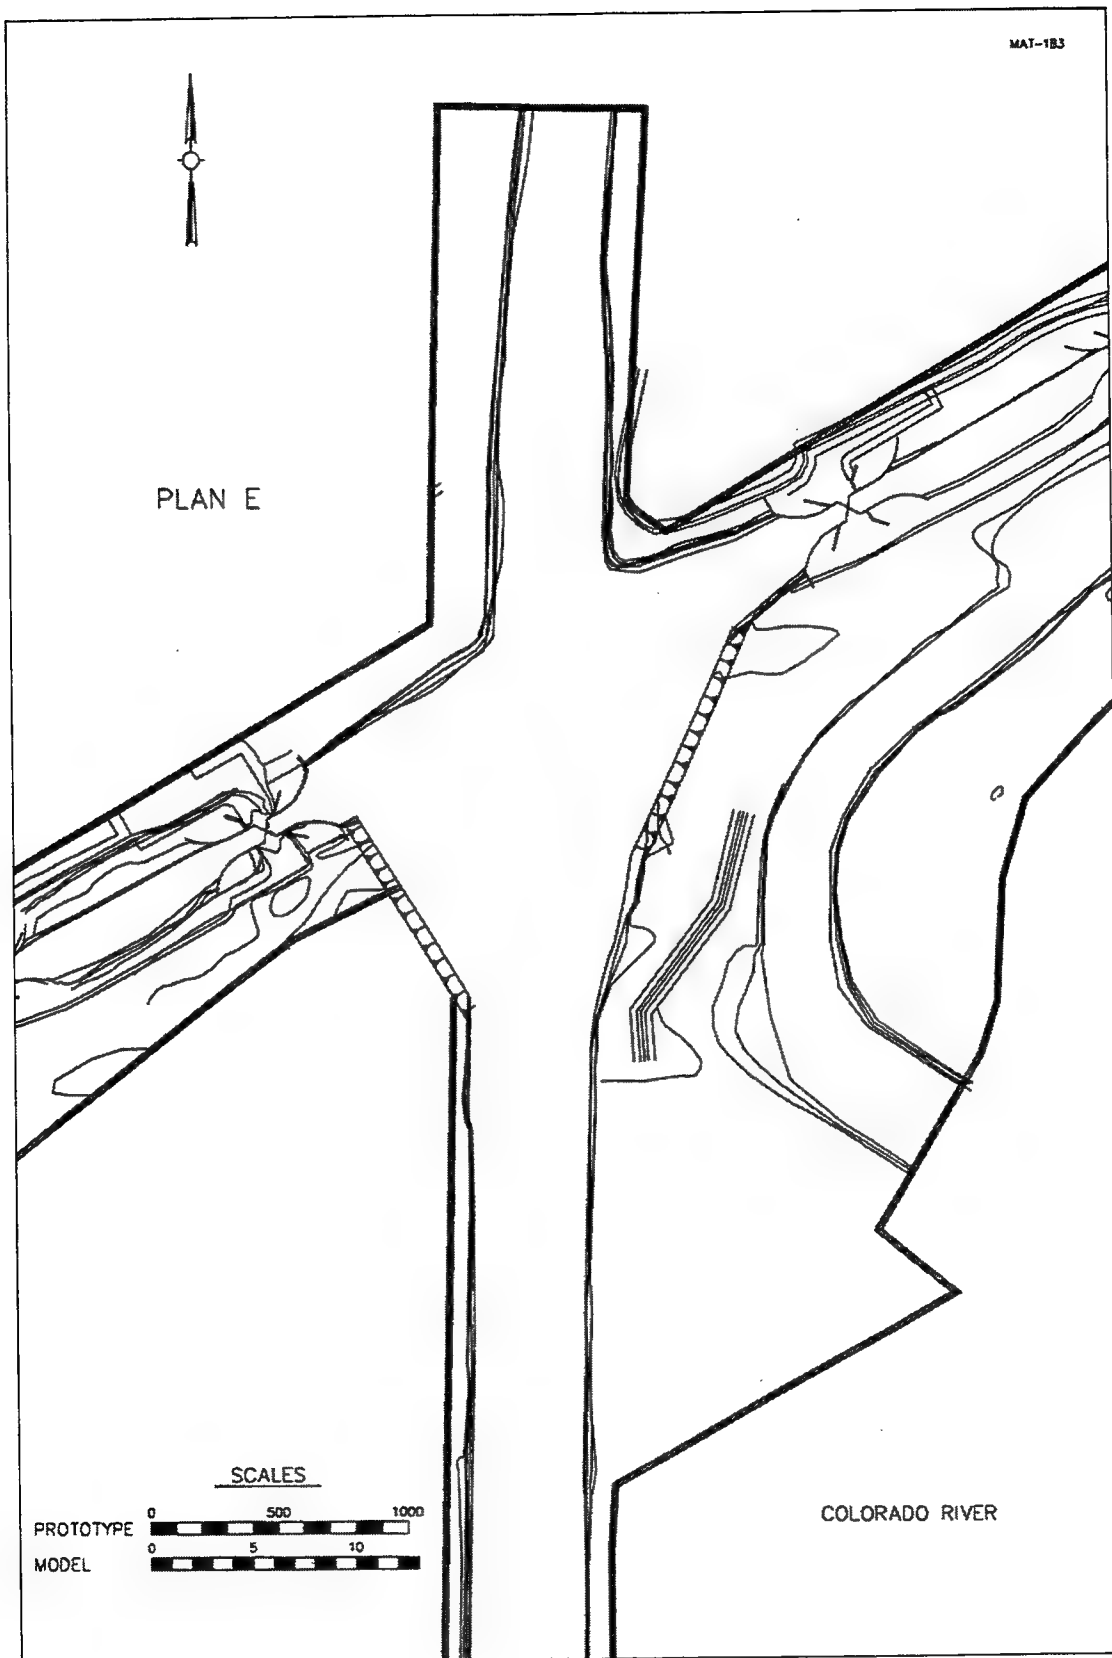
Figure 18. Plan E layout

Plan E consisted of the complete removal of the southwest and southeast corners of the Colorado/GIWW intersection (Figure 18). The bank lines were

placed to an alignment provided by the Galveston District, cut to a slope of 1 on 3, and the depth of the dredged channel was 3.66 m (-12 ft) mlt.

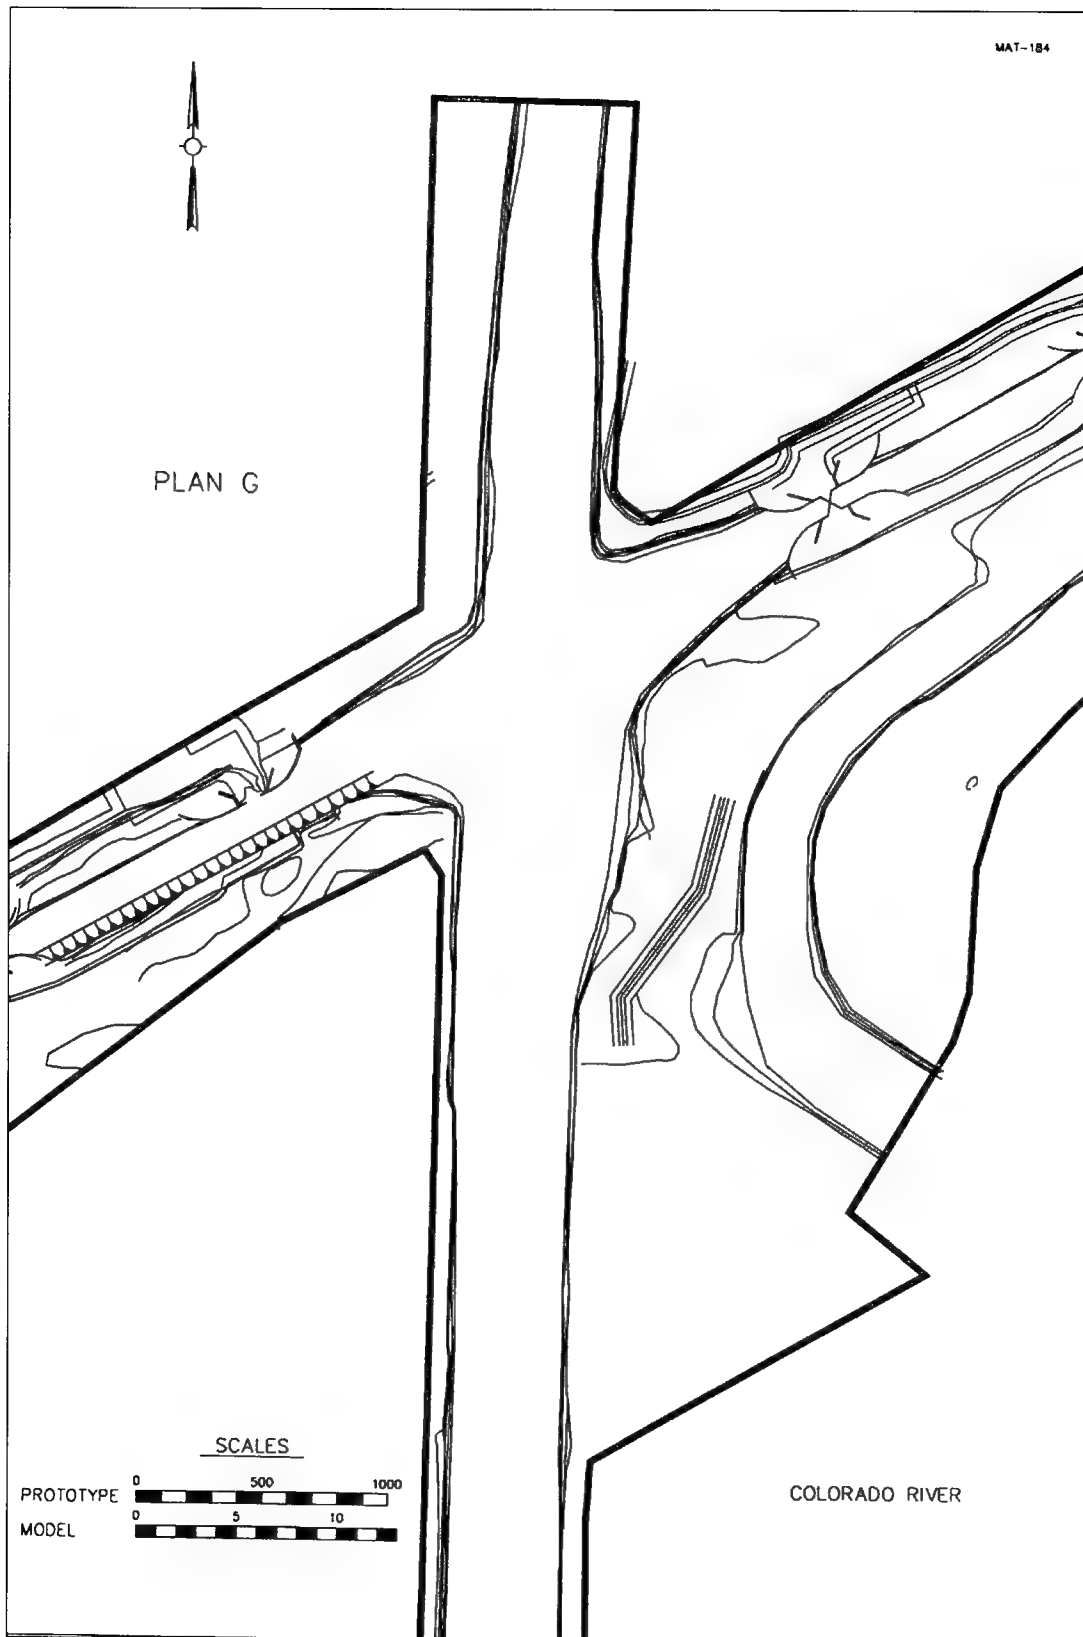
Figure 31. Plan G layout

Plan G (Figure 31) removed the south miter gate and wing wall from the east end of the West Lock, leaving the north gate and wing wall intact. This plan would be similar to the original design from the late 1940s of only single flood control gates in the GIWW on both the east and west side of the Colorado River. At that time, tows could not push through the flood gate against the current and a second set of gates were installed on either side of the Colorado closer to the intersection, forming the now existing East and West Lock. The bottom width of the channel was 38.1 m (125 ft) and an elevation of -15 mlt and the left bank line from the southwest point of the Colorado/GIWW intersection to the west gate of the West Lock was cut on a 1 on 3 slope from -15 mlt to top bank. This made the channel through the West Lock asymmetrical to the center line of the GIWW, but

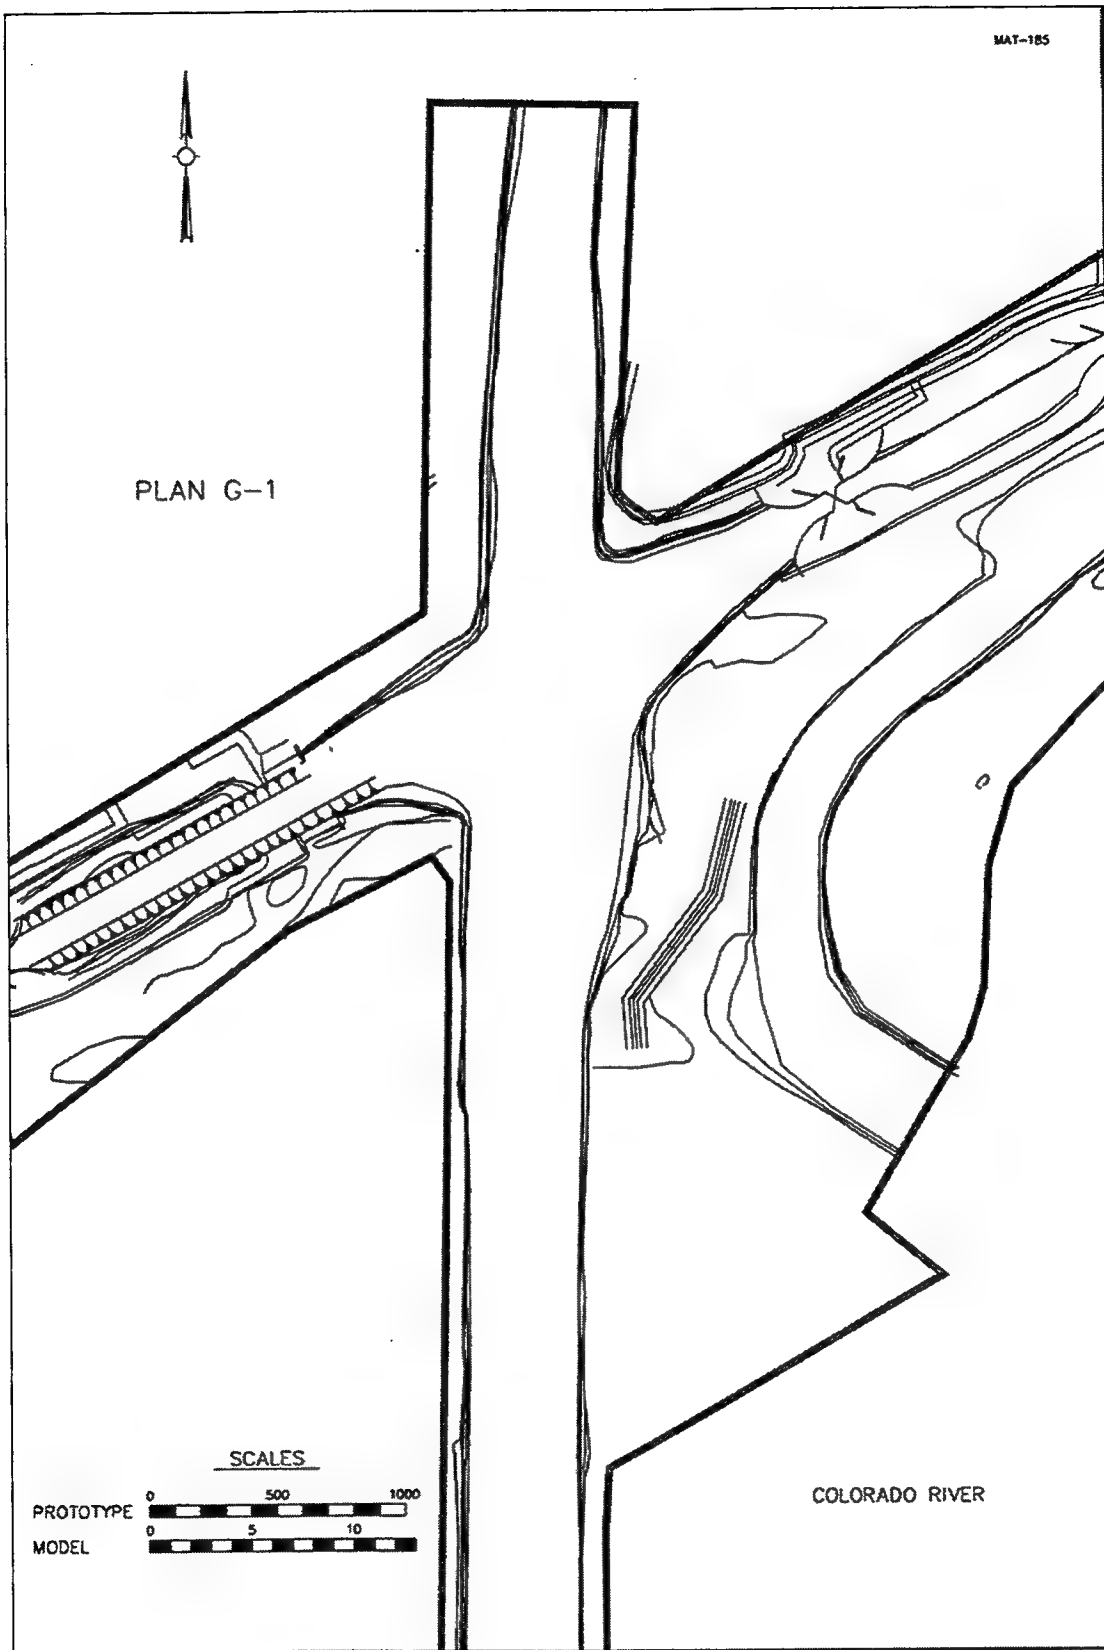
Figure 32. Plan G-2 layout

Plan G-1 (Figure 32) removed both the north and south gates from the east end of the West Lock, removing the gates, lock walls, and wing walls, creating a

symmetrical channel about the GIWW center line. The bottom width of the channel was 38.1 m (125 ft), centered on the GIWW center line, with an elevation of -15 mlt and the left and right bank lines from the northwest and southwest points of the Colorado/GIWW intersection to the west gate of the West Lock was cut on a 1 on 3 slope from -15 mlt to top bank. As with Plan G, no evaluation of how the tow might be affected by flow through the remaining set of miter gates could be performed.

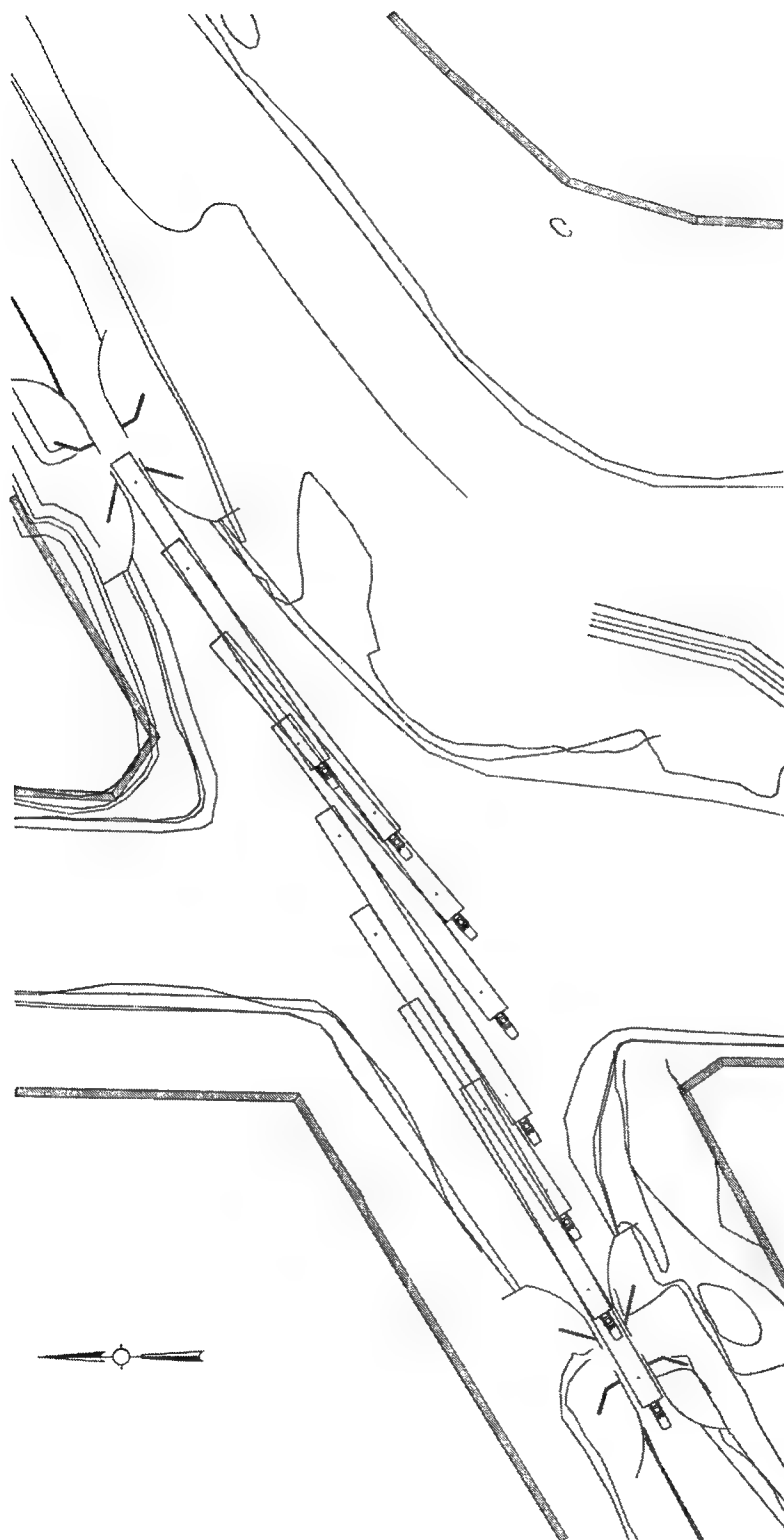
MAT-108

LEGEND

3-BARGE TOW: 3 LONG X 1 WIDE
54FT WIDE X 885FT LONG WITH
70FT PUSHER BOAT

TOW PATHS EASTBOUND

BASE TEST
DISCHARGE: 10,000 CFS
STAGE: 2.5 FT

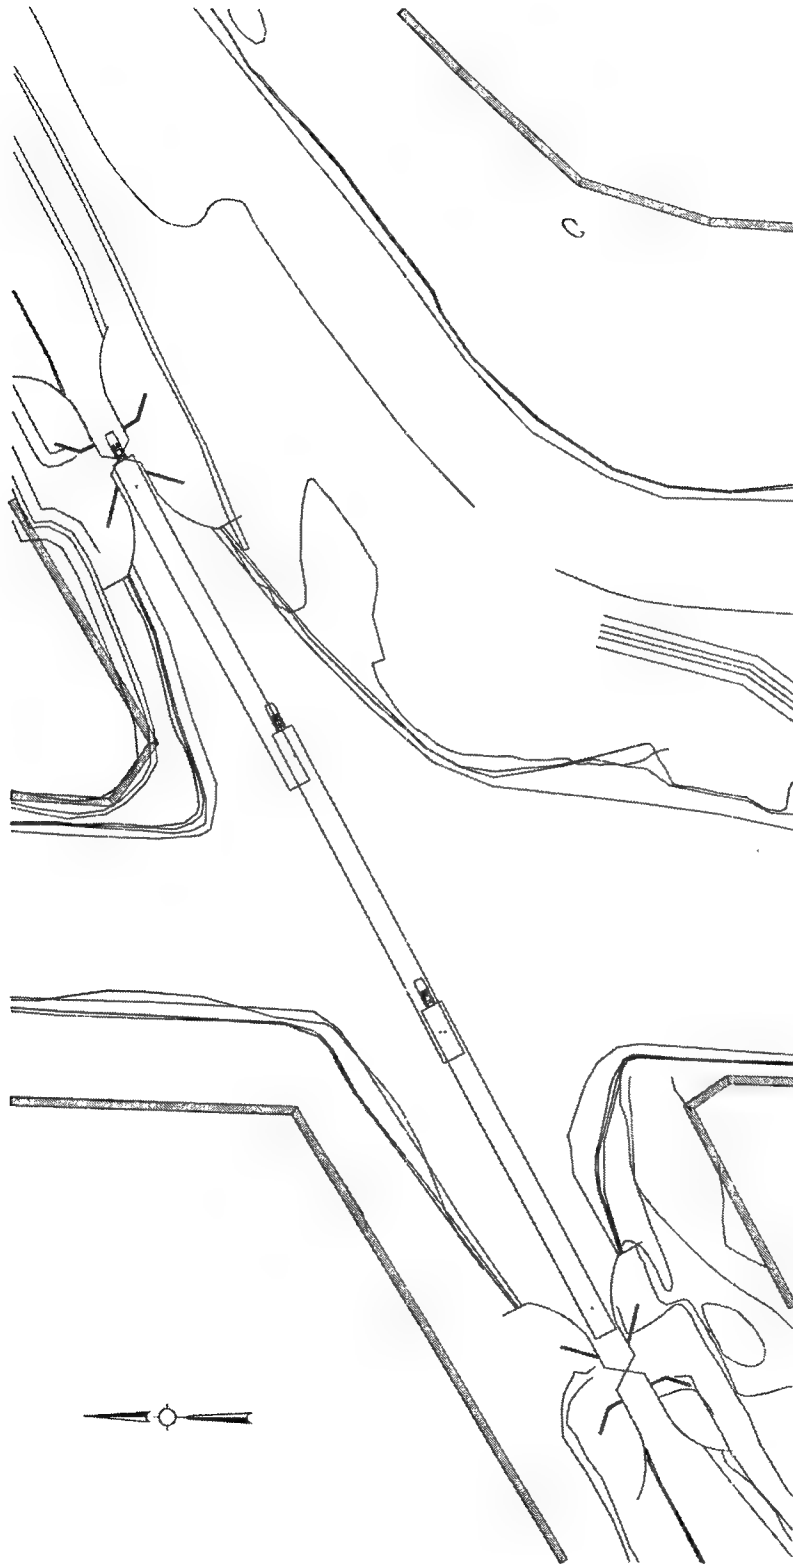
MAT-144

TOW PATHS WESTBOUND

PLAN B

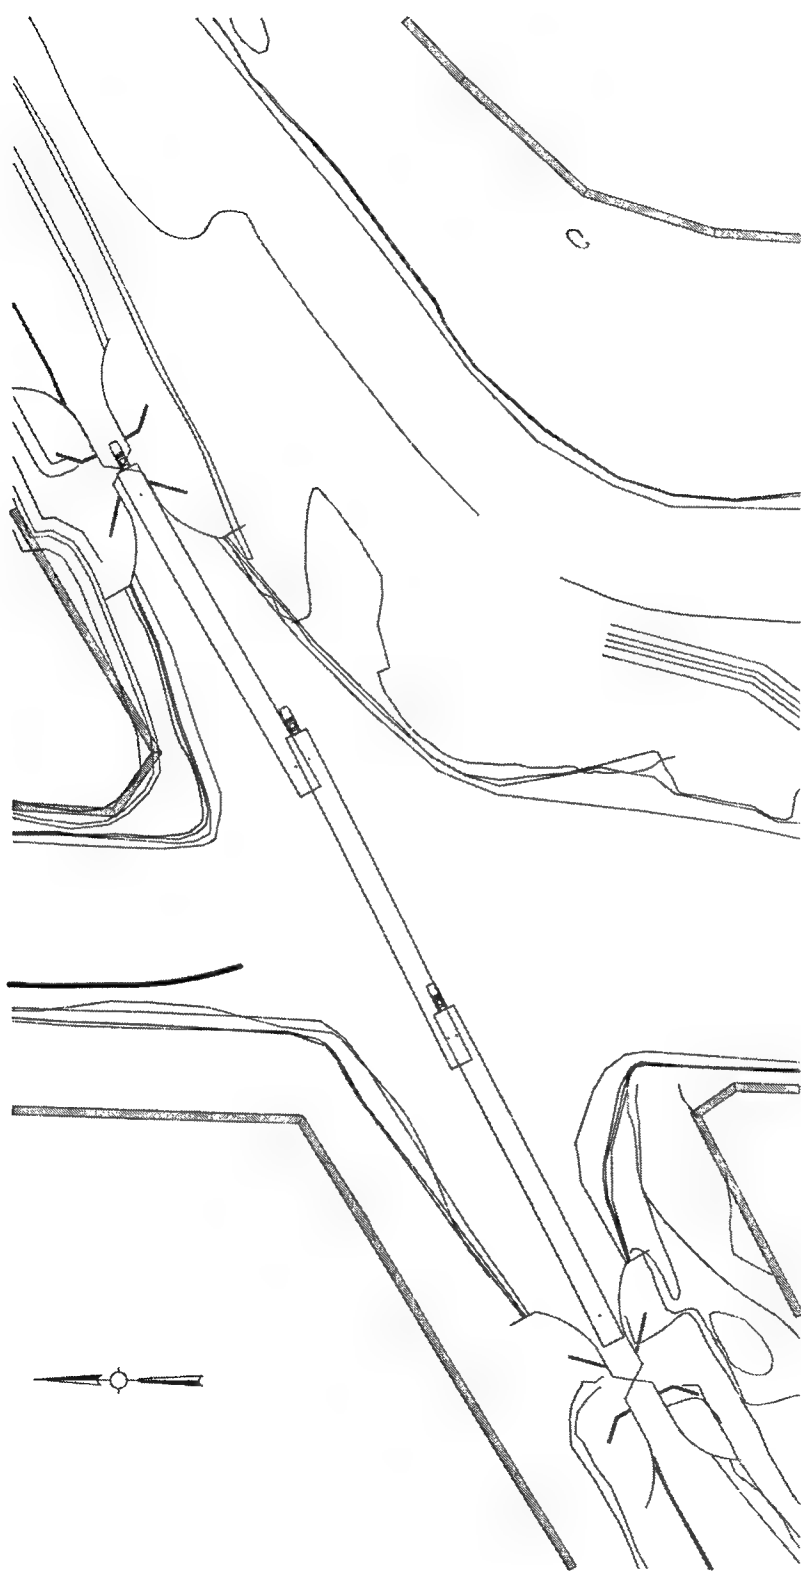
MAT-140

TOW PATHS WESTBOUND

PLAN B-1
DISCHARGE: 6,000 CFS
STAGE: 2.0 FT

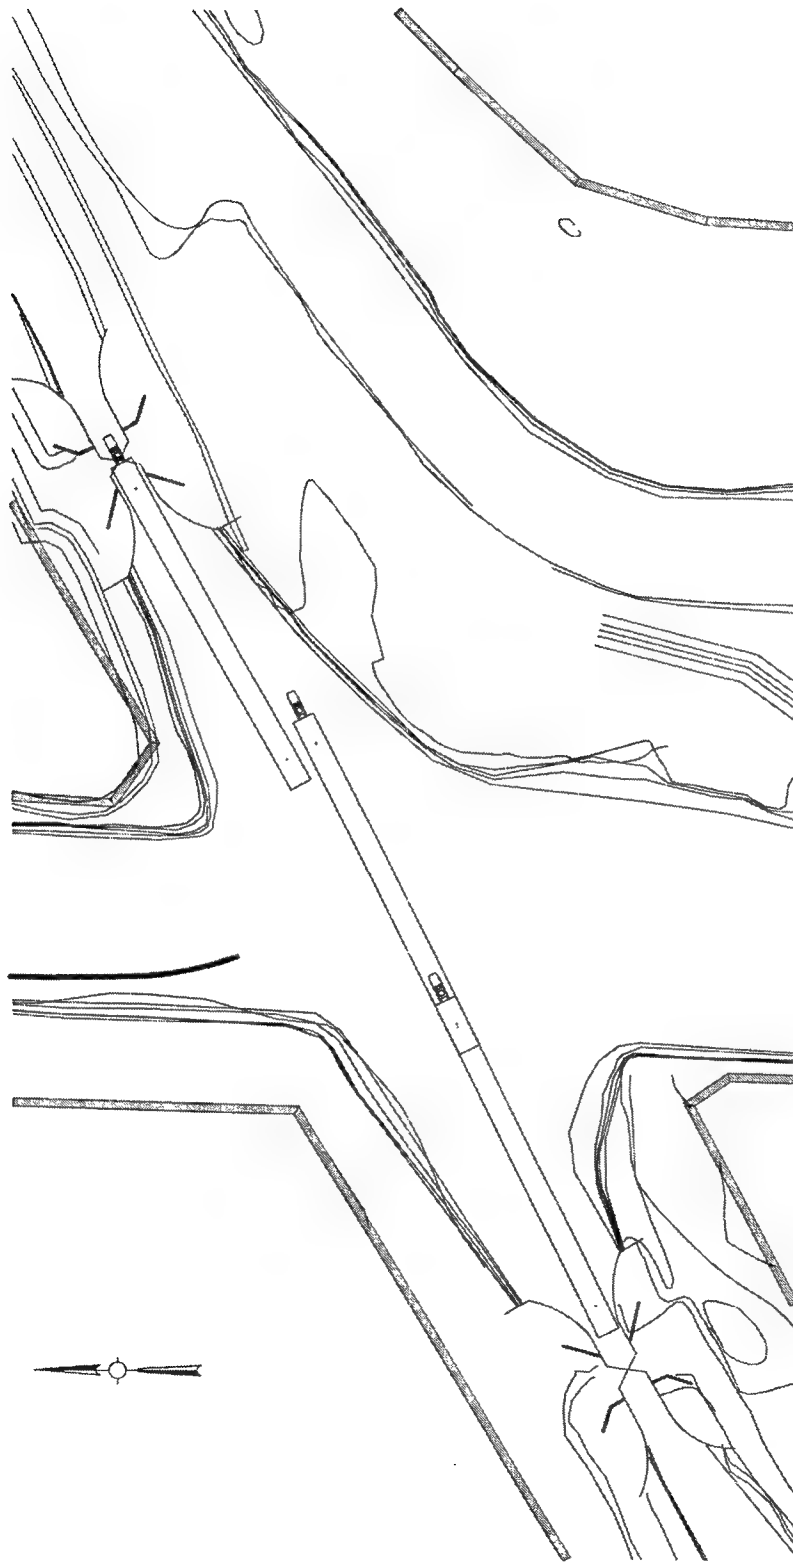
MAT-143

LEGEND

3-BARGE TOW: 3 LONG X 1 WIDE
54FT WIDE X 885FT LONG
70FT PUSHER BOAT

TOW PATHS WESTBOUND
PLAN B-1
DISCHARGE: 10,000 CFS
STAGE: 2.5 FT

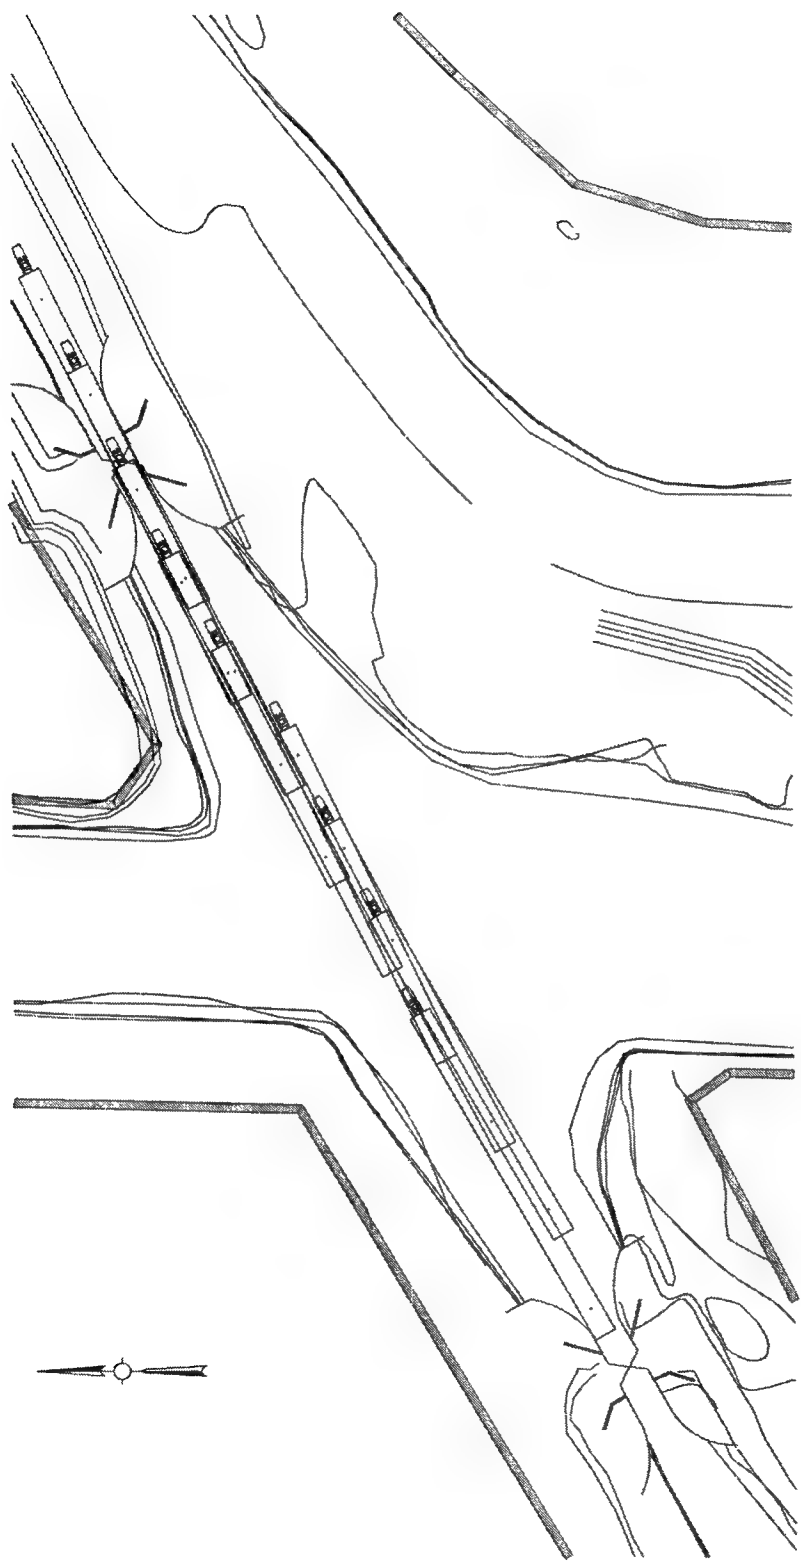
MAT-164

LEGEND

3-BARGE TOW: 3-LONG X 1 WIDE
54FT WIDE X 885FT LONG
70FT PUSHER BOAT

TOW PATHS WESTBOUND
1 FPS THRU WEST LOCK
DISCHARGE: 6,000 CFS
STAGE: 2.0 FT

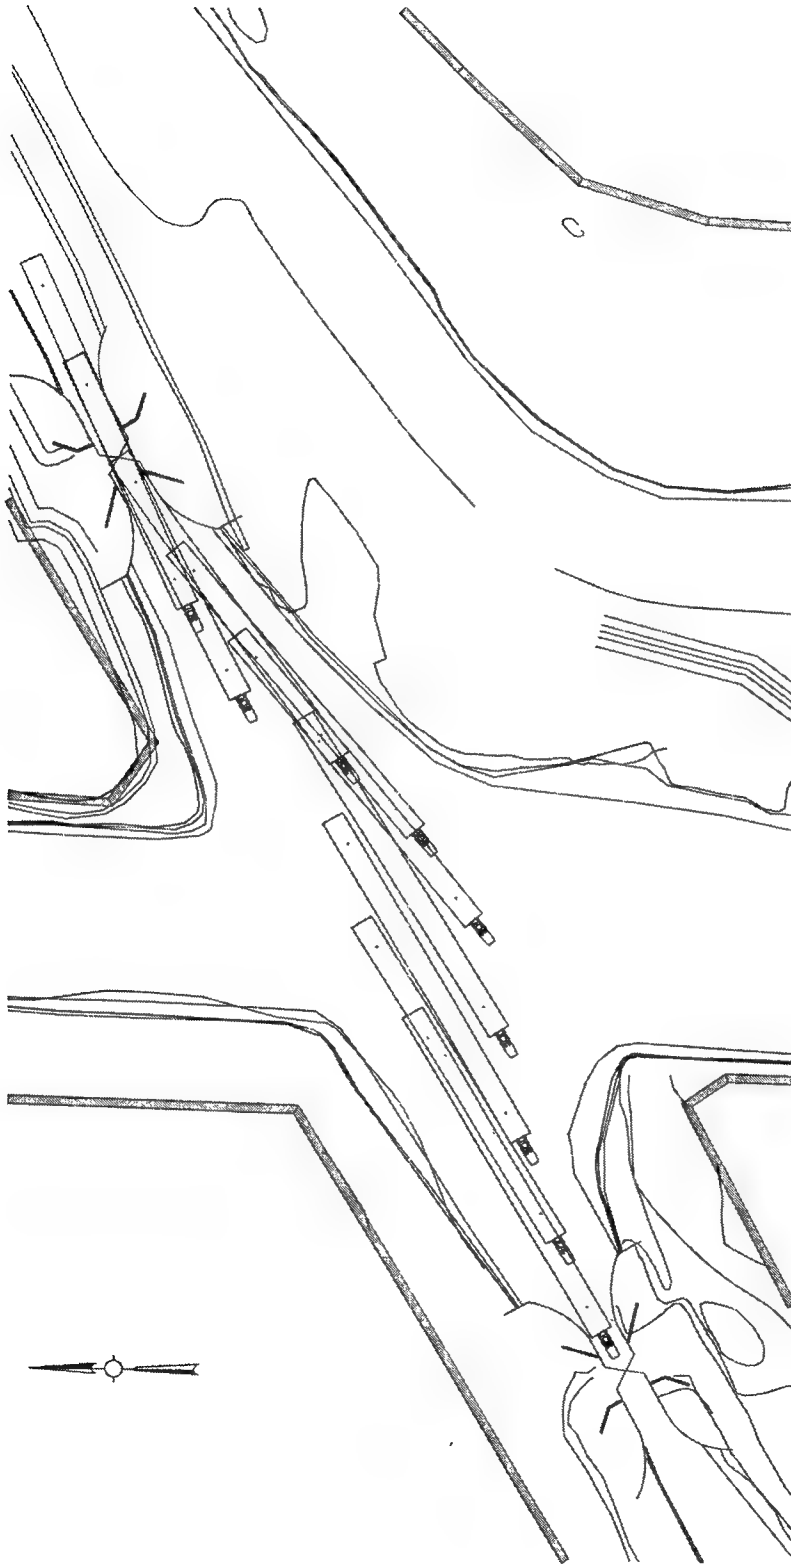
MAT-67

TOW PATHS WESTBOUND
2 FPS THRU WEST LOCK
DISCHARGE: 10,000 CFS
STAGE: 2.5 FT

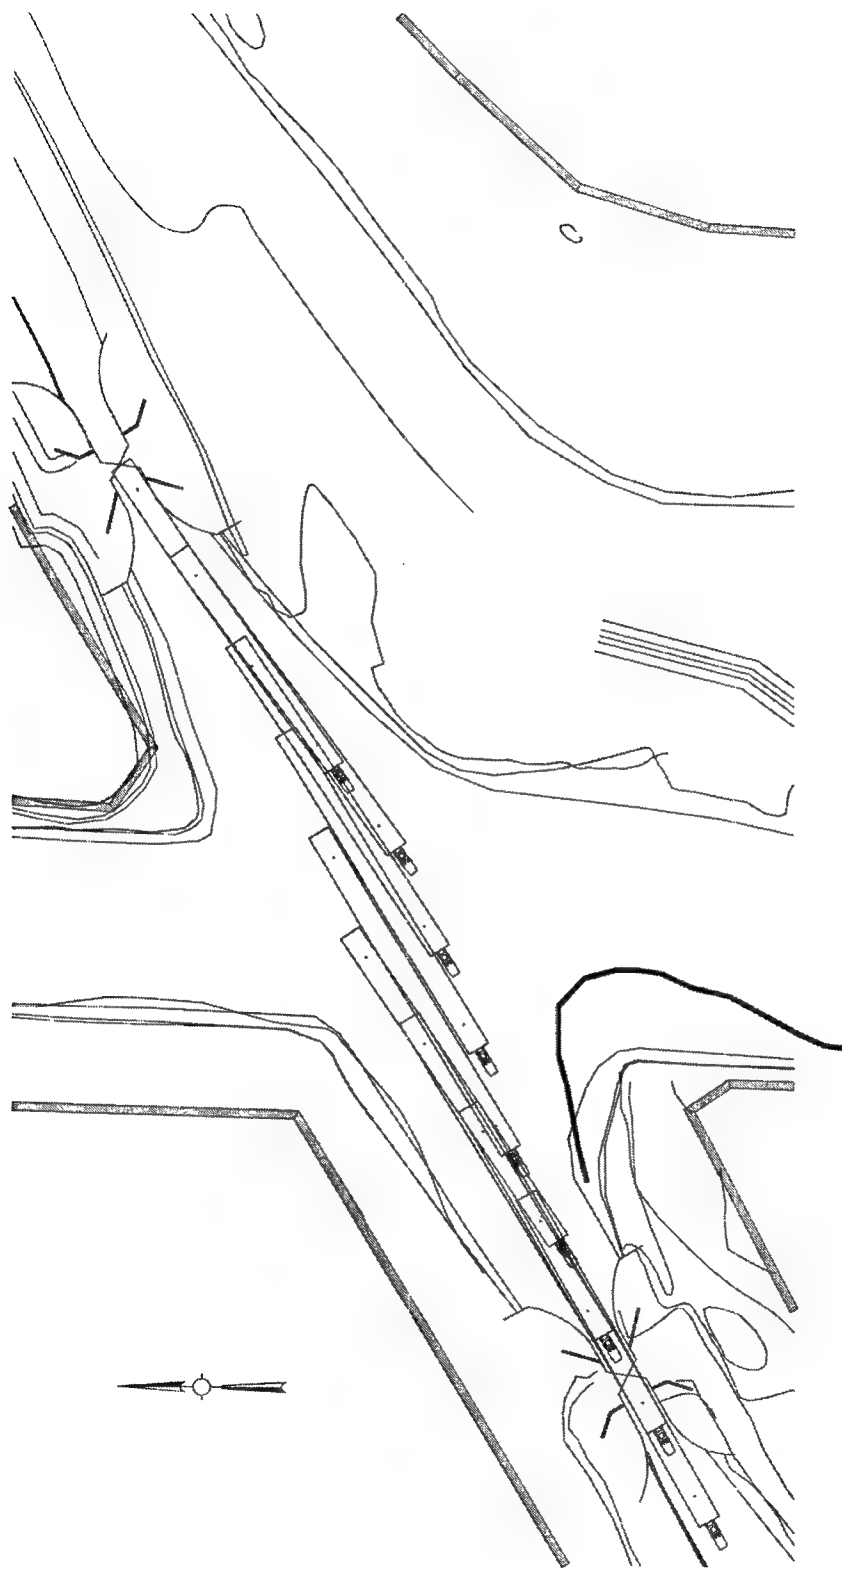
MAT-177

TOW PATHS EASTBOUND

PLAN C

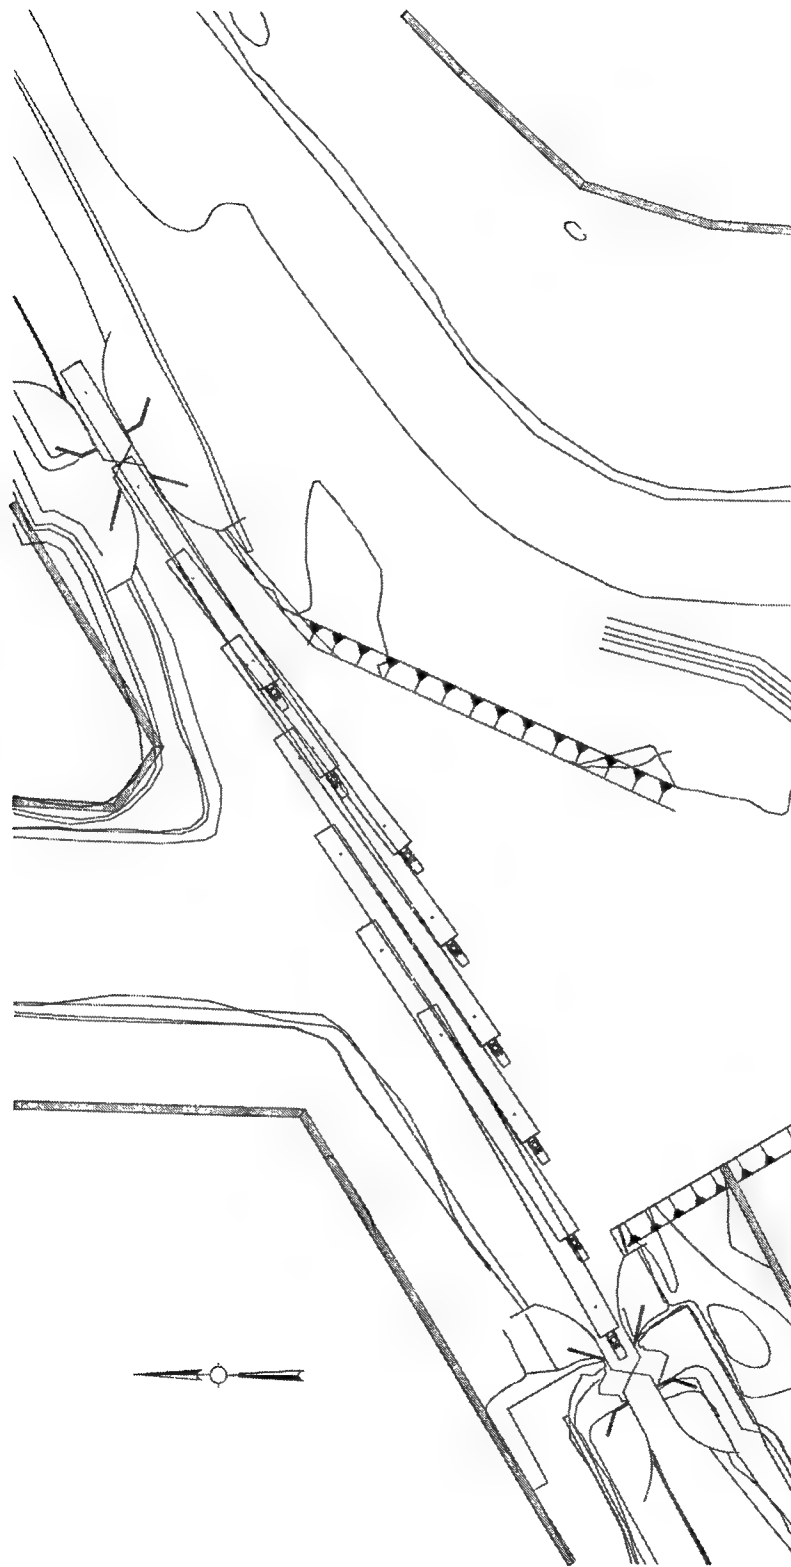
MAT-187

TOW PATHS EASTBOUND

PLAN E
DISCHARGE: 10,000 CFS
STAGE: 2.5 FT

Navigation conditions. Tows moving east to west with the 283 cu m/s (10,000 cfs) flow condition (Plate 65) had somewhat more difficulty in making the transit as compared with the base conditions. The set on the tow was more pronounced as the tow entered into the intersection and the tow could not get out of the current before the head of the tow reached the West Lock wing walls. For the west to east tows using the 283 cu m/s (10,000 cfs) flow condition (Plate 66), the crossings were also more difficult than with the base conditions. The tow could not be turned north to get an attack angle into the current from the Colorado. The tow was set well down into the intersection and tended to have the head of the tow slightly north of the GIWW center line as the tow approached the East Lock wing walls. The stern of the tow could not be steered upward into the current, even as the head of the tow was almost at the wing walls. This tended to cause the head of the tow to strike the north wing wall. To expedite the study, evaluation with the 170 cu m/s (6,000 cfs) flow condition was not performed since navigation conditions for the more critical 283 cu m/s (10,000 cfs) flow condition were not improved.

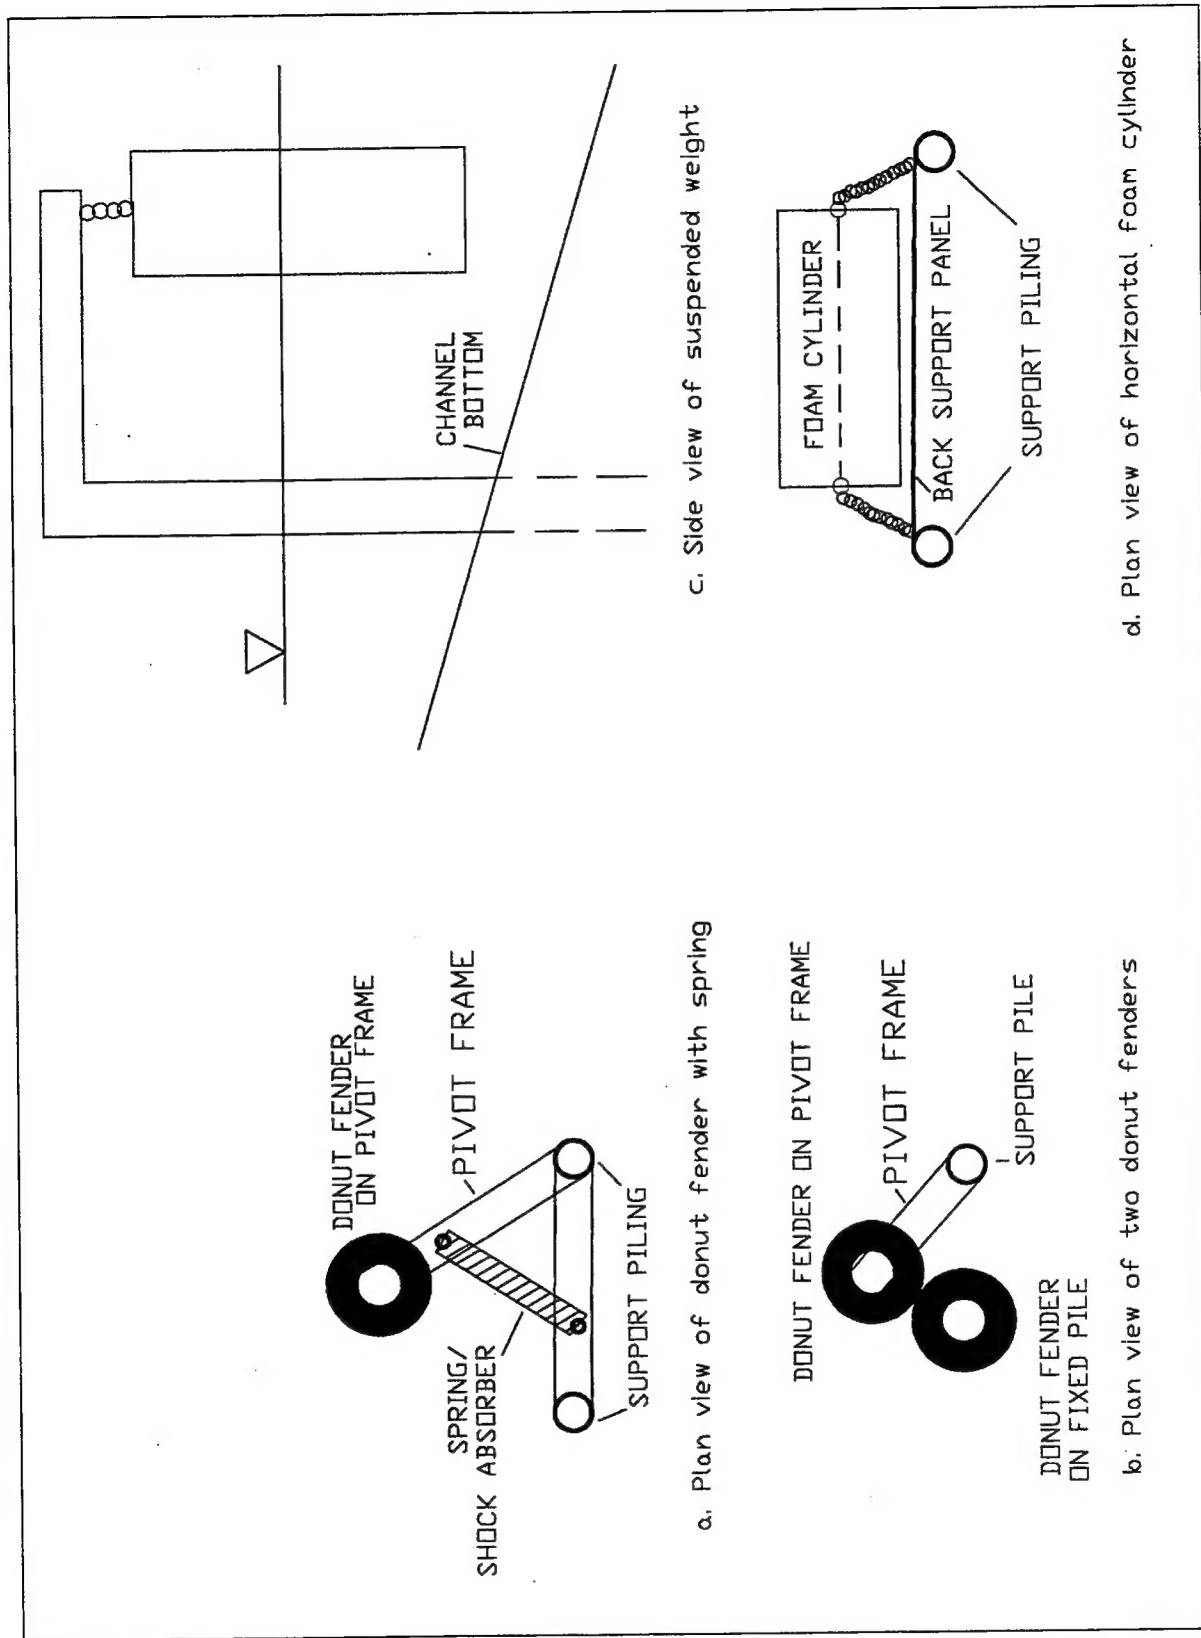
Figure A7. Landing structures for Southwest corner
